TECHNICAL SERVICE BULLETIN

Bulletin No.: 197381

Subject: BEP Smart Battery Hub Overcurrent Issue

Product Name: BEP Smart Battery Hub

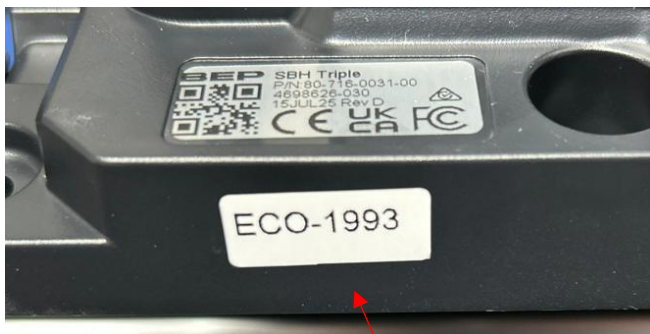
Figure 3
Location of part number
on the product

Updated products have an “ECO-1993” sticker on the product (Figure 3) and on the outer

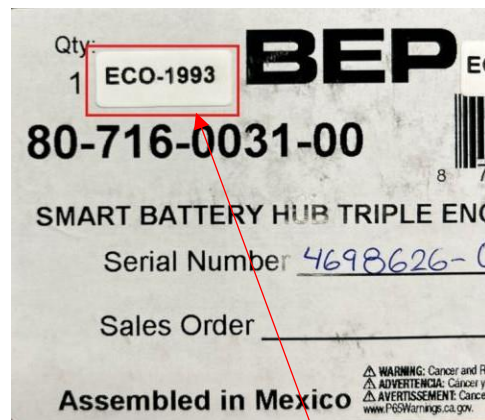
packaging (Figure 4).

Figure 4
“ECO-1993” sticker on the box.
