TECHNICAL SERVICE BULLETIN

Bulletin No.: 197381

Subject: BEP Smart Battery Hub Overcurrent Issue

Product Name: BEP Smart Battery Hub

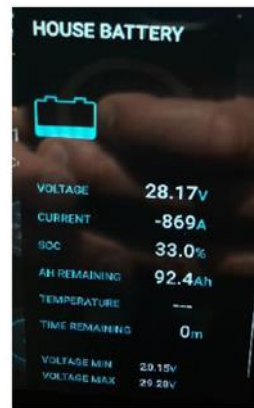
Figure 1
BEP Smart Battery Hub

Navico Group has identified an issue affecting some BEP Smart Battery Hub (Figure 1) units.

- The root cause has been identified as plating on the terminals used on the shunt connector, causing high resistance which leads to intermittent current measurement errors to be seen on the displays connected to the unit.
- The current monitoring on CZone displays (or any NMEA2K monitoring) will show as the max current, in the region of $\pm 850A$ (Figure 2). The current value may be erratic, switching between the correct value and the max current value or fixed on the max current.
- A solution has been implemented, and a rework plan by Navico Group is already in progress to ensure product reliability.
- The function of the Smart Battery Hub is not affected by the possible incorrect current value(s) shown on the monitor.
